## The Collins KWM-2: Curing T/R Switching Transients

### Unexpected Service Bulletin Side Effects

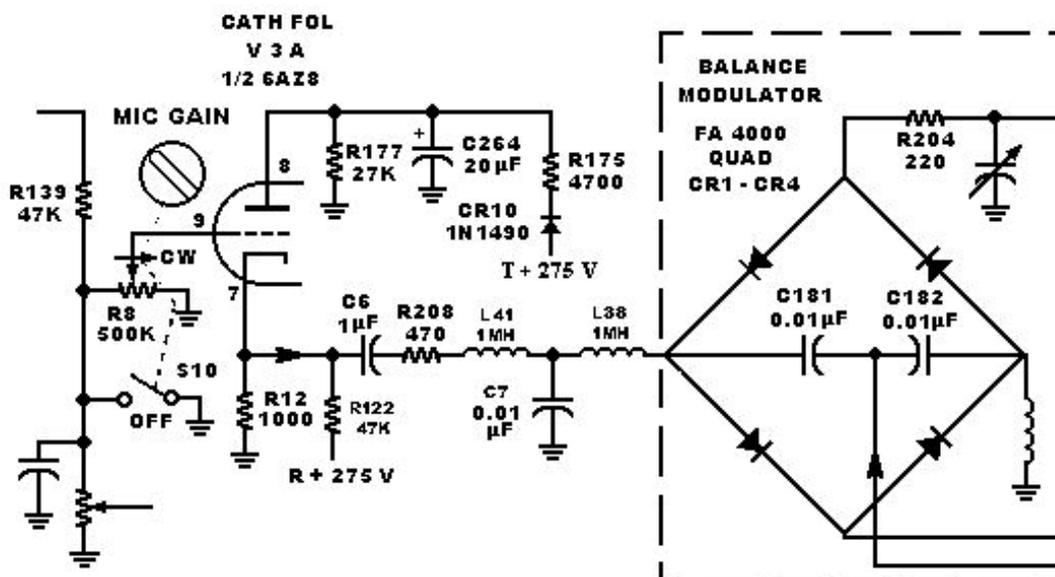
Fig. 1 Components around V3A in a Collins KWM-2

But, didn't they find this when they designed the KWM-2? Oh yes, they did. And they designed a remedy into its circuits: C264, R176, R177 and CR10 in the anode supply of V3A.

Let's look at the circuit diagram in Fig. 1 and temporarily pretend that C264 and R122 are not there. First, in receive mode, the junction of C6 and R12 in the cathode of V3A is at zero volts. After switching to transmit, V3A gets its anode voltage from the T+275V supply, immediately starts to draw current through R12 and quickly charges C6 from zero to a few volts. This causes a large bump that goes via R208, L41 and L38 directly into the balanced modulator, and from there it gets converted into an RF signal at the PA output.

Again, let's look at the circuit diagram in Fig. 1. There still is R122, connected between the R+275V supply line and C6. This resistor was introduced in May 1961 by Amateur Service Agency Bulletin ASAB 1006 to prevent an "audio squeal" when switching from transmit to receive. R122 is supposed to put a positive voltage on the cathode of V3A in receive mode, thus better cutting off V3A and preventing possible audio feed through.

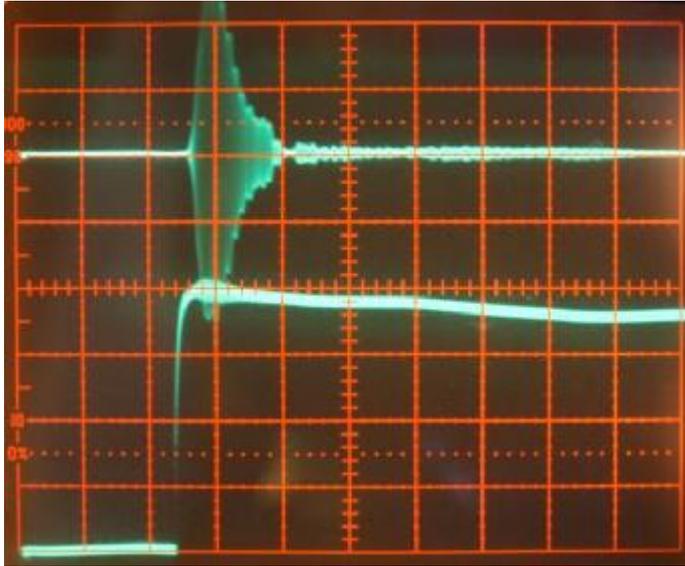
You can clearly see this in Fig. 2. This oscilloscope trace has been triggered when the PTT line was actuated. The trace below shows the voltage at the cathode of V3A. After about 12 ms, when the T+275V supply has been switched on, it quickly rises from zero to about 8 volts. The upper trace shows the RF output into a dummy load. You can see a corresponding signal spike of about 5 ms duration, which has full peak-to-peak PA output.

Fig. 2 RF output (top) and voltage at cathode of V3A (bottom), when switching from receive to transmit, Mic Gain off, **without C264 and without R122** horizontal resolution 5 ms / division

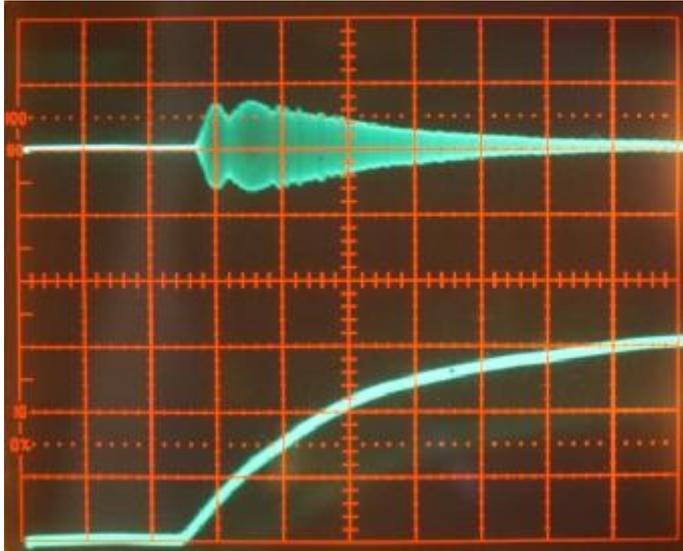
When you compare the circuitry in Fig. 1 (without C264 and R122) with the corresponding circuit in a KWM-1, you can see that this bump is probably also present in a KWM-1. So at design time for the KWM-2 this effect must have been known and a remedy was searched for. As a consequence C264 and R176 have been put in the anode circuit of V3A. Now, when the T+275V line is switched on, the anode voltage of V3A is rising much slower and the current change through R12 is also slowed down. Thereby the bump into C6 is reduced. The result can be seen in Fig. 3.

Fig. 3 RF output (top) and voltage at cathode of V3A (bottom), when switching from receive to transmit, Mic Gain off, **with 4 $\mu$ F for C264 and without R122** horizontal resolution 5 ms / division

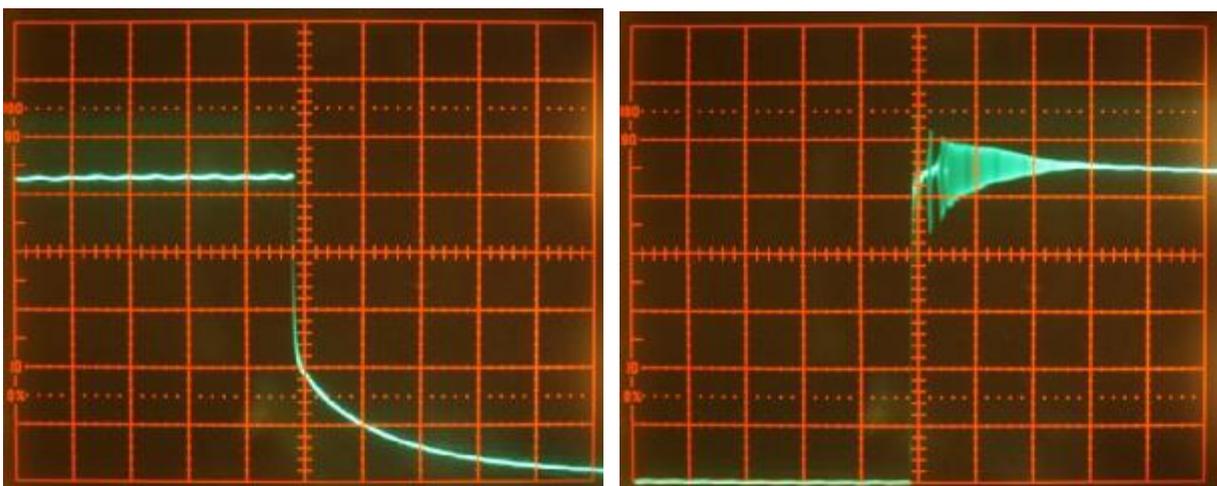
Initially C264 had a value of 4 $\mu$ F, which must have been a compromise between slowing down the current increase through R12 and at the same time preventing a new side-effect that happened when the KWM-2 was switched back from transmit to receive. The charge on C264 keeps the T+275V supply line high for a short moment, when the R+275V receiver supply is already on. And although R177 has been added to quickly discharge C264, the small remaining charge is enough to cause regeneration around receiver stages. This oscillation can easily be seen at the anode of V3B, the second IF amplifier (see Fig. 4).

Fig. 4 Voltage on T+275V line (left) and voltage at anode of V3B (right), when switching back from transmit to receive, Mic Gain off, **with 4 $\mu$ F for C264 and without CR10** horizontal resolution 20 ms / division

Of course, this oscillation enters the AVC circuit and causes the S-meter on my KWM-2 to jump to nearly S9, every time I switch back from transmit to receive.

This adverse effect was only cured after diode CR10 was introduced in October 1965 by Amateur Service Agency Bulletin ASAB 1016. Now the charge on C264 can no longer flow back onto the T+275V line and it is therefore possible to increase C264 to the later value of 22 $\mu$ F. This further reduces the bump into C6 and in the RF output, as can be seen in Fig. 5.

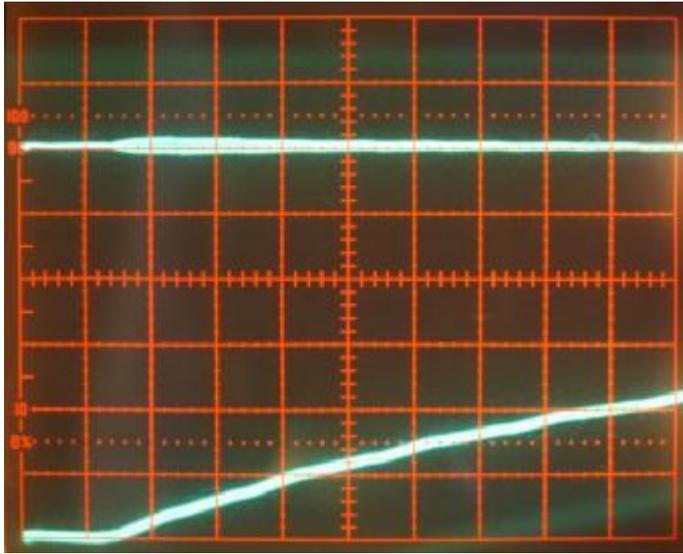
Fig. 5 RF output (top) and voltage at cathode of V3A (bottom), when switching from receive to transmit, Mic Gain off, **with 22 $\mu$ F for C264 and without R122** horizontal resolution 10 ms / division

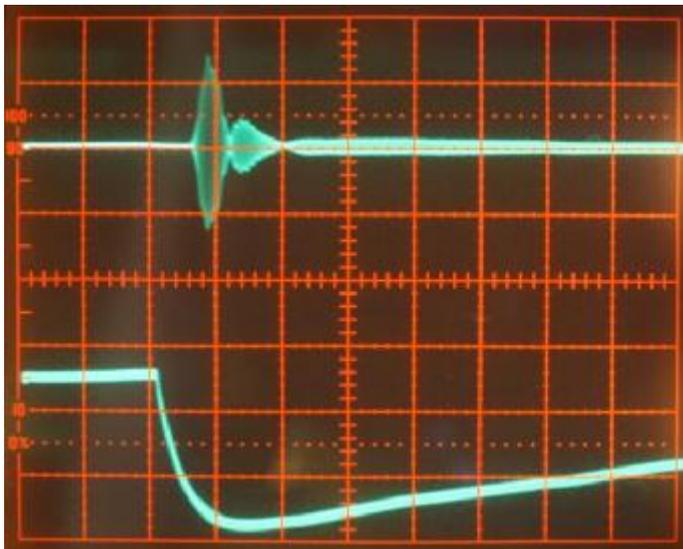
Fig. 6 is a further oscilloscope screen shot that shows the result. You can clearly see the new sharp negative transient at C6 and the corresponding large click at the RF output, which on my KWM-2 has about 60% of full peak-to-peak output.

Fig. 6 RF output (top) and voltage at cathode of V3A (bottom), when switching from receive to transmit, Mic Gain off, **with 22 $\mu$ F for C264, CR10 and original R122** horizontal resolution 5 ms / division

So the root cause for the bump noise is found: The addition of R122 according to ASAB 1006 may have solved one problem, but it clearly has aggravated a problem that once seemed to be solved.

Convinced? Then give it a try, remove R122 (47 K $\Omega$ ) between V3 and turret E40. Check whether the problem described in ASAB 1006 exists for your KWM-2. If not - leave it that way. I can promise you, most of the noise when switching from receive to transmit will be gone. But also gone will be the click sound of a true Collins KWM-2, so it's up to you what you want.
