My Collins KWM2

My Collins KWM-2

My Collins KWM-2 Restoration Project

The Collins KWM-2: Curing T/R Switching Transients

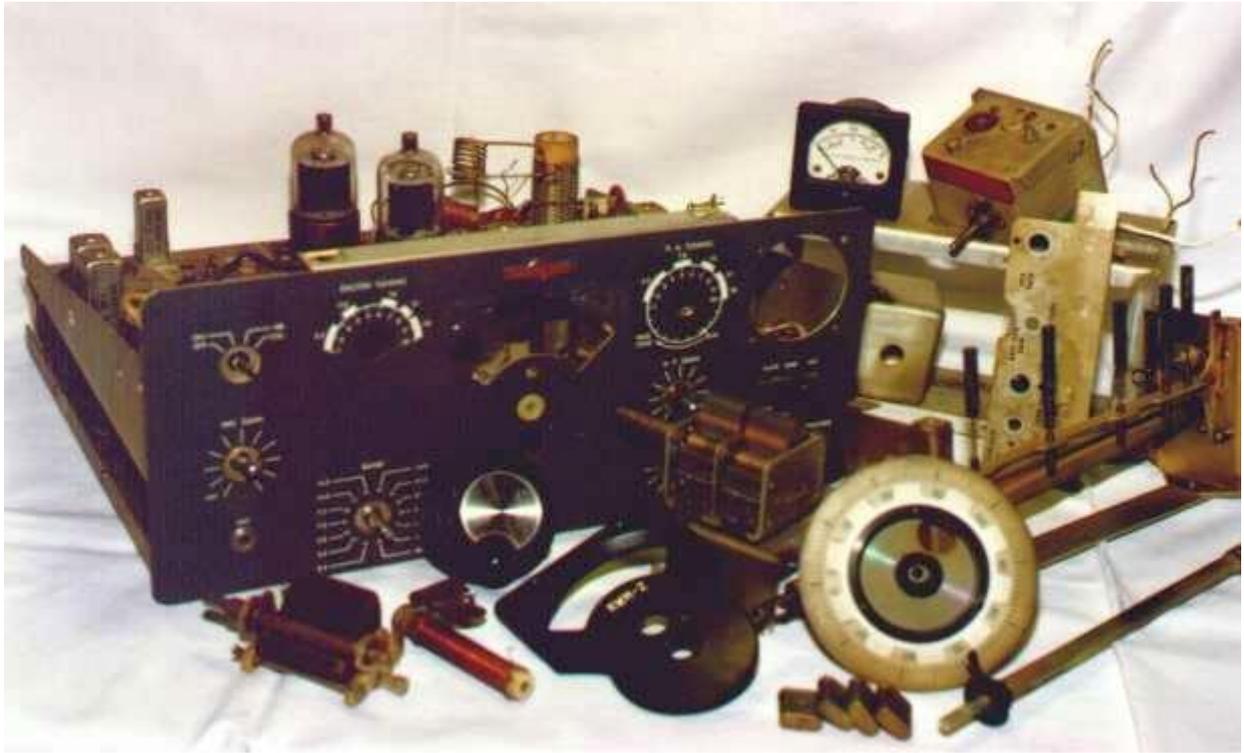
Yes, this is how my Collins KWM-2 looked like, after I had started with the restoration job.

Lots of brown stuff covered the characteristic grey, green and aluminum colors of the Collins S-line.

So, I applied common sense and standard engineering and radio repair techniques. First I carefully cleaned and got the PM-2 to work. Then I gave the KWM-2 a try with all tubes removed. Smoke!

After some searching I found that the installed Waters rejecting tuning model 340A had several mechanical shorts, which had taken with them a choke in the filament circuits.

No question, the Waters had to move out and the choke was replaced. Then I started the cleaning process. First I dismantled

everything that could be removed, and then I started a gentle cleaning process, not the brutal "water from a hose and let dry in the sun" that is sometimes advocated.

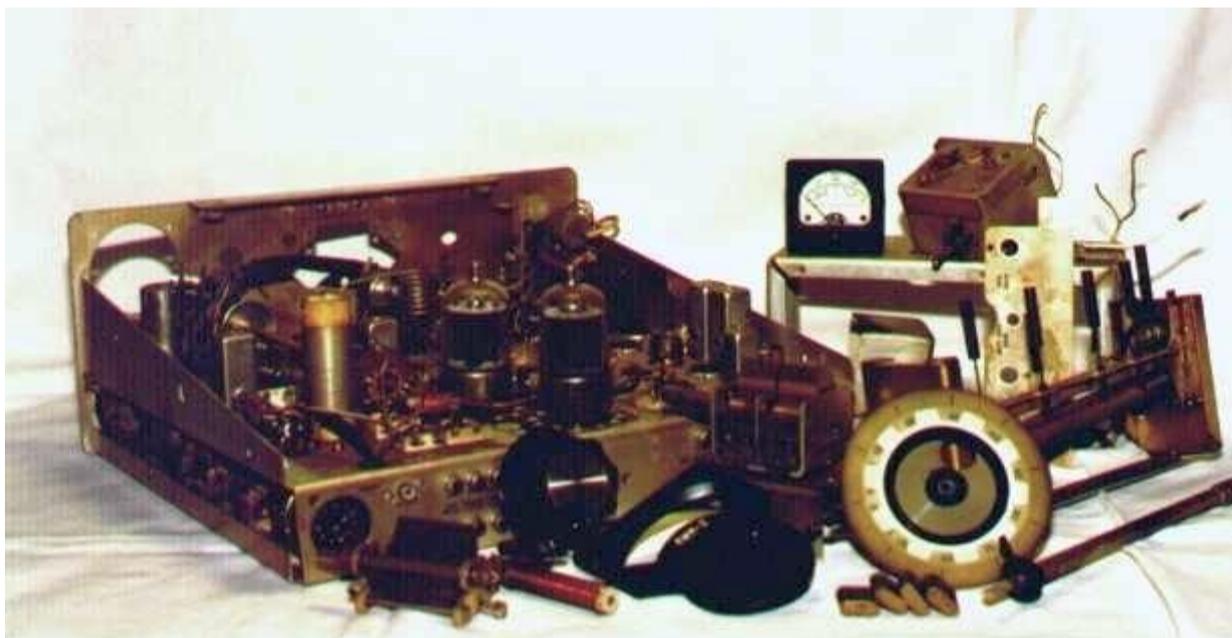
Here is another picture, seen from the back. Of course, the PA tubes are just there to show their position, not for cleaning them.

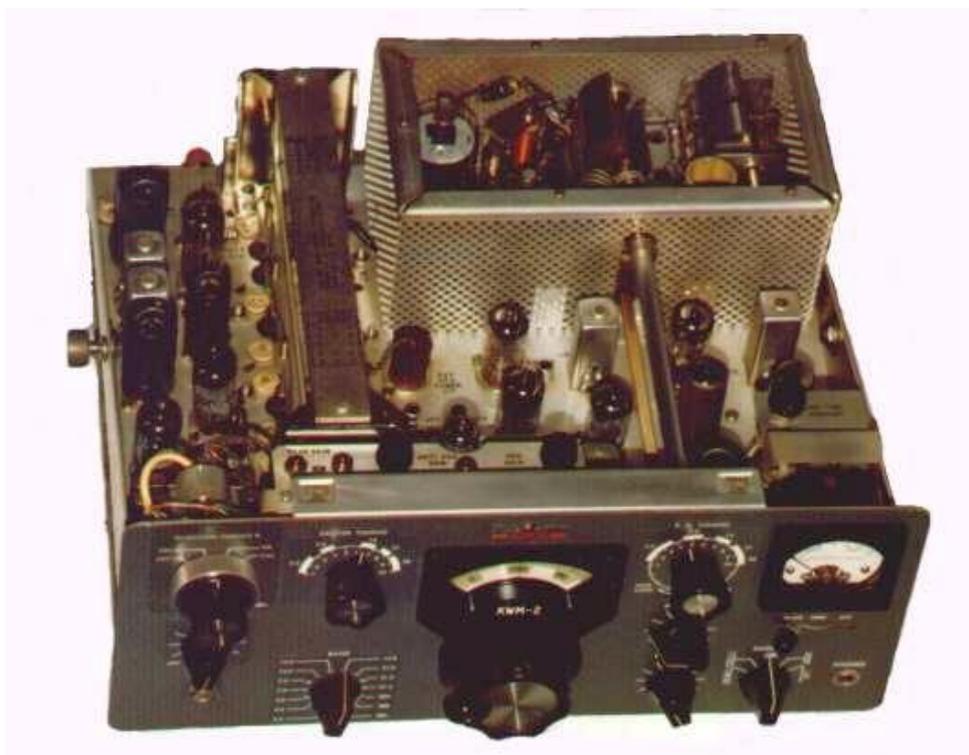
And this is how it looks now after all the work I put into it: clean and shining. A pleasure to look at, a real work of Art.

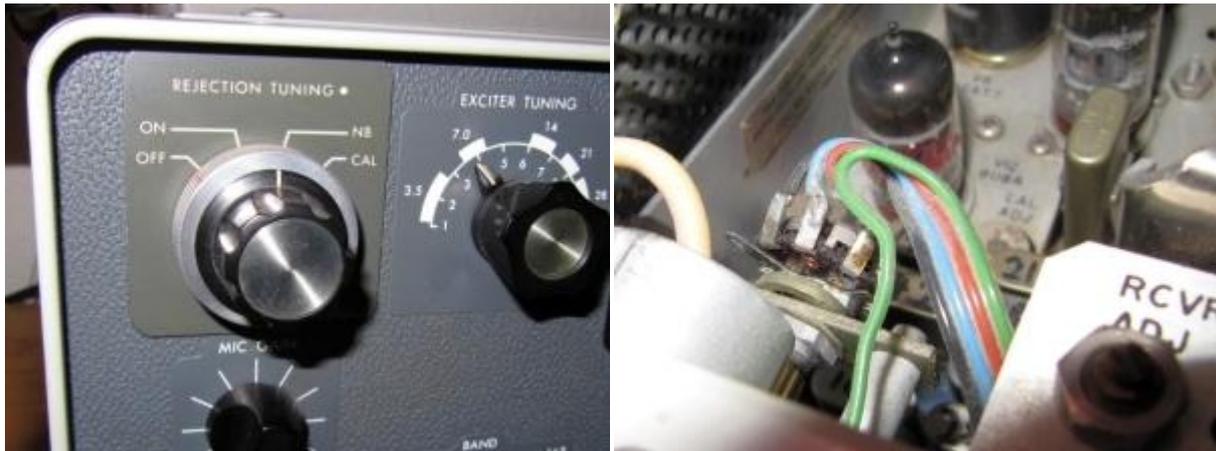
And my KWM-2 had a defective Waters rejection module. That had to move out and the tuning capacitor that was mounted concentric with the ON/OFF switch was replaced with a potentiometer for the variable bias voltage. As there is no noise blanker installed, the NB switch position can be used as RIT-ON. That even ensures that in CAL mode the RIT is always off.

Here you can see the concentric former rejection tuning and power switch, and the RIT potentiometer mounted on the bracket that formerly held the variable capacitor.

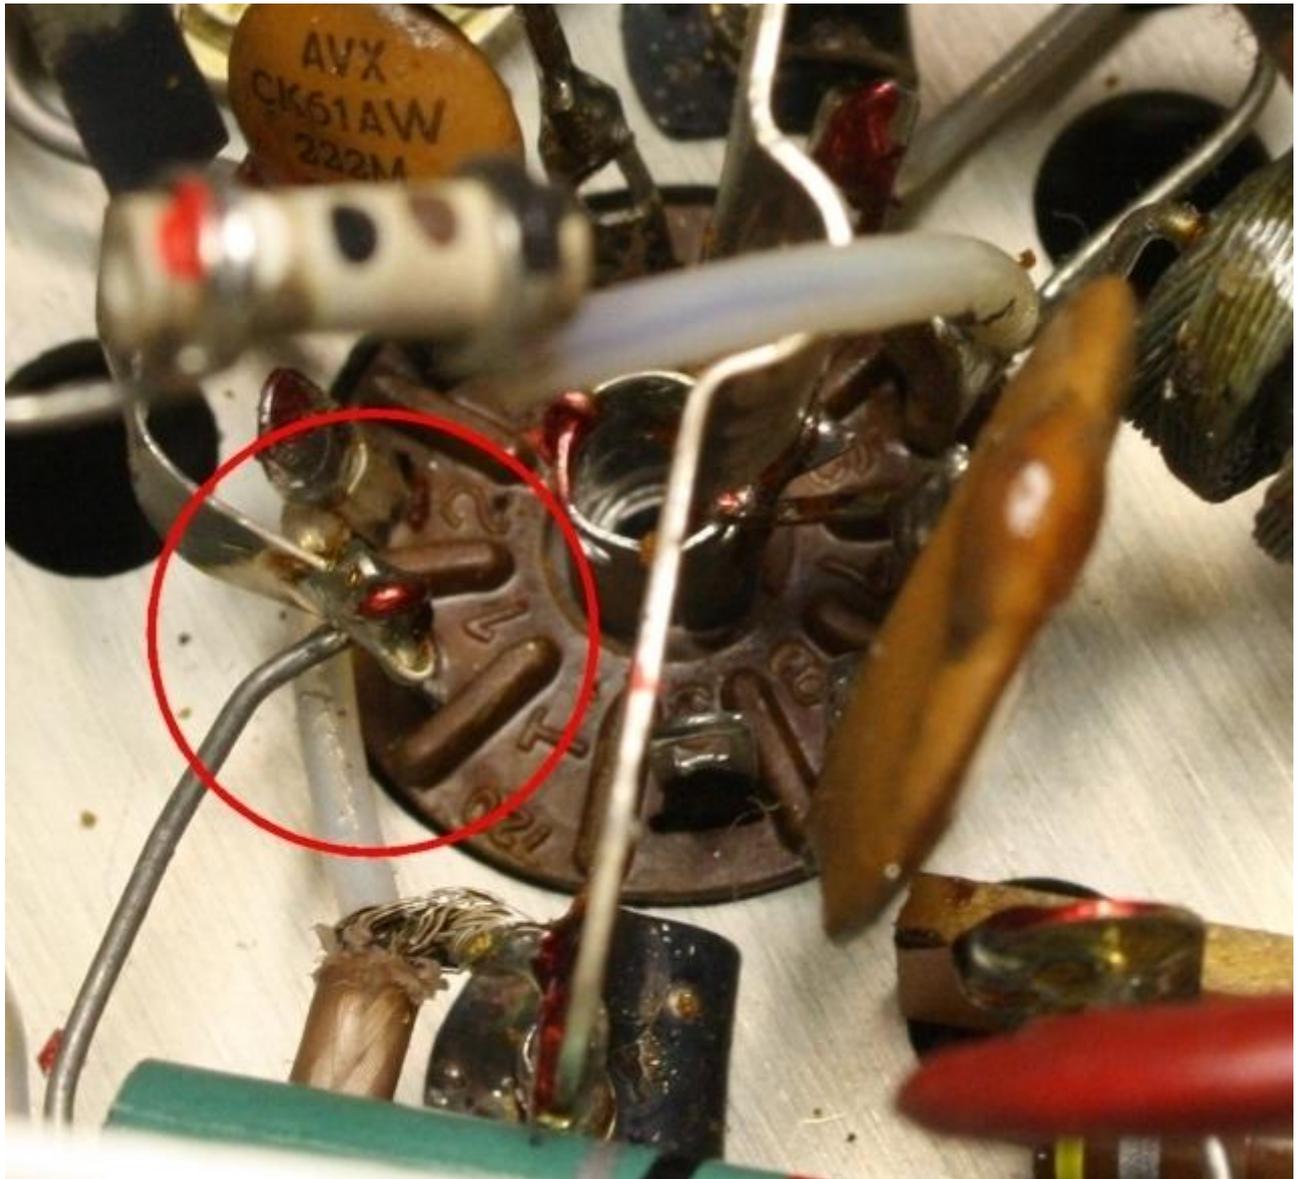
Now the mechanics of the problem were clear: any contact between pins 1 and 2 of V8 causes a severe de-tuning of the circuit in the anode of V7. That is why the calibrator's signal had been much too low and no peaking had been possible. The driver stage V8

Problem solved. And as I did not see any sense in dismantling the connection further for closer inspection, I can only speculate about the root cause. That center conductor must have been close to the lug at pin1 right from production time, maybe there even had been a tiny cut in the insulation. Vibrations and low temperature on the air transport from US to Denmark may have caused something like cold-flow of the insulation: This must have caused an even closer contact until finally an instable electrical contact was established. Tapping the chassis must have broken that contact, restoring proper operation momentarily. Repeated heating of the chassis may have relieved the strain and broken the contact again until only very hard mechanical shock was able to restore it momentarily. So, as I had feared, the problem might have disappeared altogether when the transceiver had been running in a cozy warm shack for some days. But who knows, it might have come back, haunting the operator.

This picture shows the space underneath driver tube V8, the circle highlights the place where the inner conductor goes past the lug of pin 1.
